WAYPOINTS

October - December 2007

Tech Tip: Differential Replacement

Tech Tip: Mallory Distributor Replacement

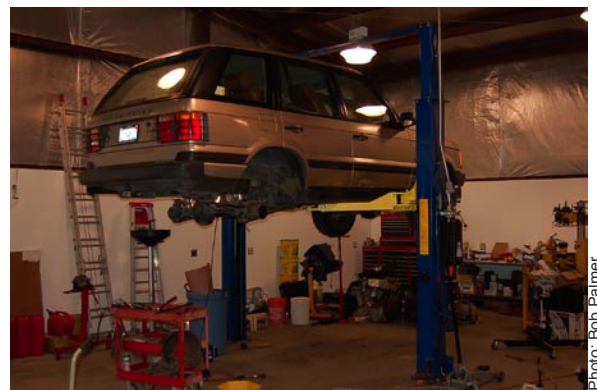
Top: The Range Rover up on the lift with the rear wheels, axles, and differential removed.

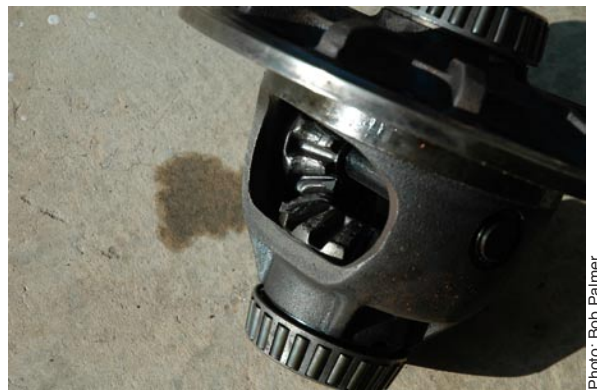
Now it was possible to inspect the damage. The gear teeth on the side and spiders gears had been worn down to the point where they no longer meshed. No teeth had been broken, it was just the gradual wear and metal abrasion due to lack of proper lubrication. Some teeth looked like they might have been chipped as a result of the clunking and lurching. Also the ring and pinion looked fine, so replacing the differential carrier with the locker would solve the problem.

Above: Worn gears in the old carrier.

Next was the discussion of how to fix the problem. Replacement spider and side gears are available for under \$200. However, this seemed like the ideal time to upgrade the truck by putting in an ARB Locker. The locker would be about \$1000, the ARB compressor another \$270, and about \$60 for the bearings.

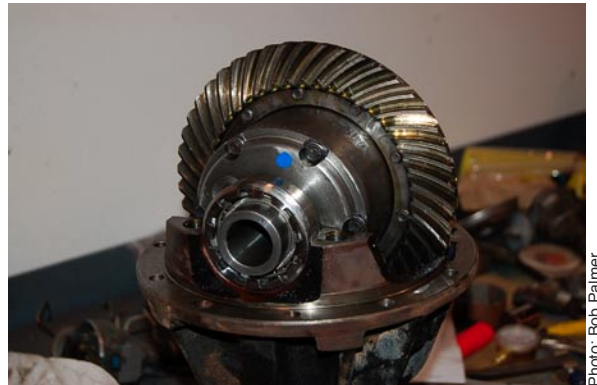
There was a large amount of backlash, and the locker was up against the opposite bearing support. The bearing support cap is a rough casting. We tried milling the cap to increase clearance. But the locker was also rubbing against the bottom part of the bearing support, and the adjustment nut was too far out of the bearing support. It became obvious that something was wrong. The first candidate was the locker. We found the answer on the ARB web site under the Air Locker Parts and Service documentation. On the RD56 page, there is a note that states the RD56 is for the non-traction control differential with a flange diameter of 174mm [6.85"]. For the traction control version with a 205mm [8.07"] flange, the RD57 should be used. After measuring the flange diameter, it was clear we had the wrong locker.

The difference appears to be that the traction control differentials use a thinner ring gear, so the carrier flange is shifted toward the center of the differential, and the flange is larger to provide more backing support for the ring gear. A spacer plate is also available, but longer ring gear bolts would be required.

Monday morning, it was back on the phone with Atlantic British explaining the problem, and where the correct data could be found. They sent out a RD57 locker and new bearings, only charging the difference between the RD56 and RD57. The key thing here is that the ARB application guide data is incorrect, and does not mention the selection based on the flange diameter. All US specification Range Rover 4.0/4.6 have rear traction control, and 1998 on have both front and rear traction control. The ring gear bolts are the same, so if the bolts appear at the outer edge of the flange it will be the non-traction control version. The traction control flange is 1.22" larger than the non-traction control flange. So the ring bolts will appear to be inset further from the edge of the flange. This can be seen through the oil fill plug on the differential housing, so a first level check can be performed without removing the pumpkin.

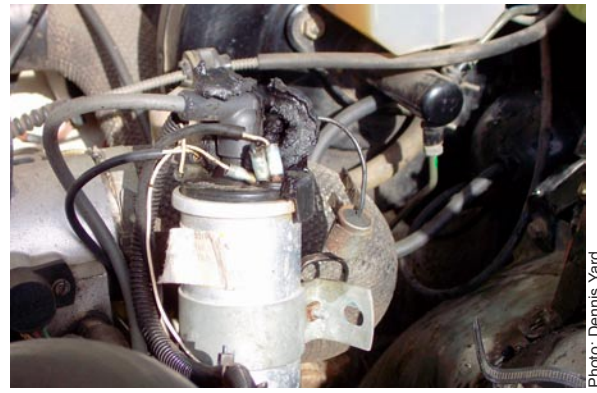
To my dismay, I immediately noticed that the ignition coil, which has the terminals pointed downward, had a black tar-like substance extruded on the attached wiring. Upon removal of the coil bracket from the wing mount I found that nearly the whole top was encased in this "tar". With a screwdriver, I chipped off the material and found that it was being extruded from the coil body from under the black plastic cap on this coil style. Evidently the coil was overheating thus causing the insulating material inside to be squeezed out.

I put out an email to local San Diego Club members, one of whom instantly recognized the fault as being caused by failure of the ignition amplifier module which is mounted on the side of the Lucas Model 35LM8 distributor. It had not been moved off the distributor body to the wing bracket per a Land Rover service bulletin recommendation. The relocation evidently was to keep it from cooking from due to engine and manifold heat.

Photo: Lucas coil leaking black tar

After some discussion as to whether to replace it with Genuine kit or to use a more modern replacement, I decided to go with a US made, modern optical distributor. I chose the Mallory Model #4768901 with matching Model #29219 ignition coil and Model #700 ballast resistor. The distributor is a "47" Series with vacuum advance. In this case I chose reliability and parts availability over originality. This is because I would like to have more peace of mind when using the 110 off-road or longer trips.

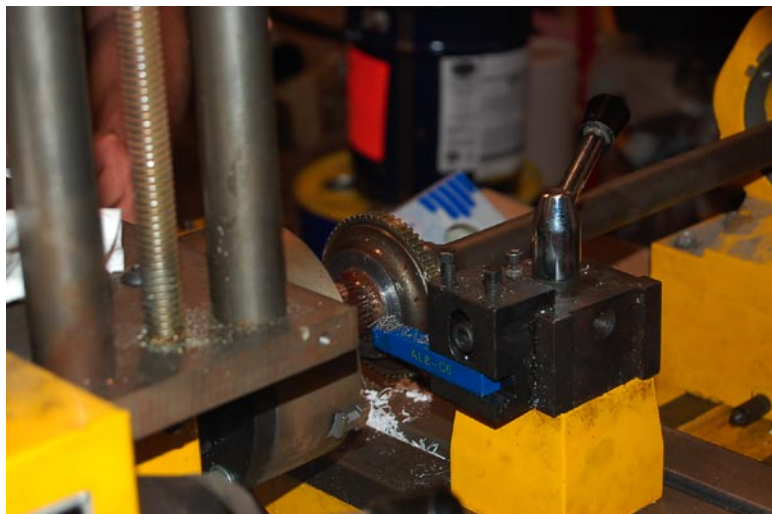
Permatex the Right Stuff® is used to form the gasket between the differential housing and the pumpkin. A bead of the elastic rubber material is laid down all the way around the differential housing. The material sets up in about a minute, so the pumpkin is quickly inserted, and bolted up to the housing. Next the axle and hub assemblies are reassembled. The right side (long) axle fit perfectly. But the left side (short) axle would not go in all the way, so the hub would not mate up against the axle tube flange.

Bottom: Rust and red Loctite on the hub axle splines

Joe had experienced this on his Range Rover also. The solution is to machine about 0.100 inches off the axle flange that sets the axle position relative to the hub. It appears the effective depth of the splines on the current Land Rover axle are not deep enough for the locker. So now we had to remove the axle from the hub. This should be floating, held in place by the axle nut on the outside of the hub. However, we could not get the axle nut off, even using in pneumatic impact wrench. Nick ended up buying a bigger impact wrench, and after a minute of pounding the nut finally came free. But the axle still would not slide out of the hub. Land Rover axles are supposed to be field replaceable, but we were having problems working in a shop. We took the axle and hub over to the 12 ton hydraulic press, nothing moved. Next we sprayed penetrating oil on the axle, and hub, and trying pressing again. Still nothing. Finally we got out the torch to heat up the hub. This is risky, because we didn't want to damage the wheel bearing in the hub. Finally with heat, oil, and 12 tons of pressure the axle broke free from the hub and we were able to press it all the way out. Between rust, and the red Loctite that the Land Rover manual says to apply to the axle

splines passing through the hub, a seemingly simple step became very difficult. Now we could take the axle over to the lathe, and machine 0.100 inch off the flange. Needless to say, we did not apply Loctite when reassembling the axle and hub.
