WAYPOINTS

October - December 2007

Tech Tip: Differential Replacement

Tech Tip: Mallory Distributor Replacement

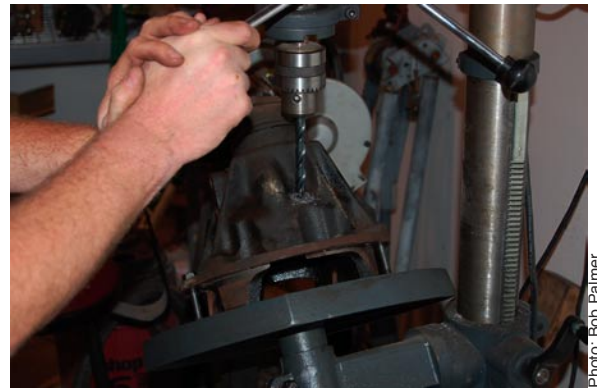
- Top: Drilling the pumpkin for the air line connector.*
- Middle (2): Locker with ring gear attached on the bench, and resting in the bearing supports.*
- Bottom: Routing the air line.*

The first step in installing the locker is to determine the location for the air line connector, and drilling the hole for the air connector. This wants to be on the top side the differential, and protected from damage as much as possible. It needs to be a relatively flat area on the pumpkin that can be drilled, and then tapped for the ¼ inch NPT fitting. The pumpkin was bolted to the drill press table, and the table adjusted so the hole would be perpendicular to the surface. It is very important to prevent any of the drilling filings from getting into the differential.

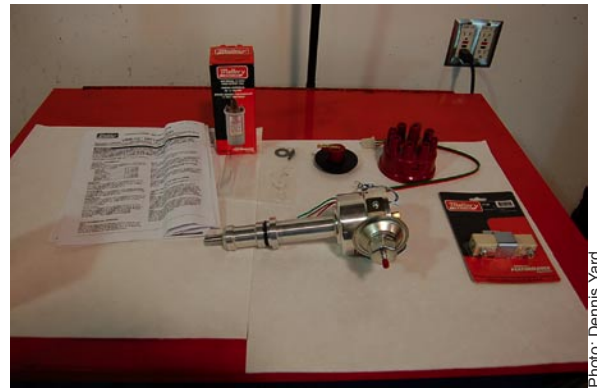
Photo: Mallory distributor, coil, and ballast resistor

After some discussion as to whether to replace it with Genuine kit or to use a more modern replacement, I decided to go with a US made, modern optical distributor. I chose the Mallory Model #4768901 with matching Model #29219 ignition coil and Model #700 ballast resistor. The distributor is a "47" Series with vacuum advance. In this case I chose reliability and parts availability over originality. This is because I would like to have more peace of mind when using the 110 off-road or longer trips.

The Mallory Model #29219 is designed for use on the Rover V8. It has a billet turned aluminum body, ball bearing support of the distributor shaft, optical (no mechanical parts or points) triggering of the spark and sealed electronics. It is a simple three wire hook up, with no modifications to the truck required, other than adding the ballast resistor to the coil bracket mount.

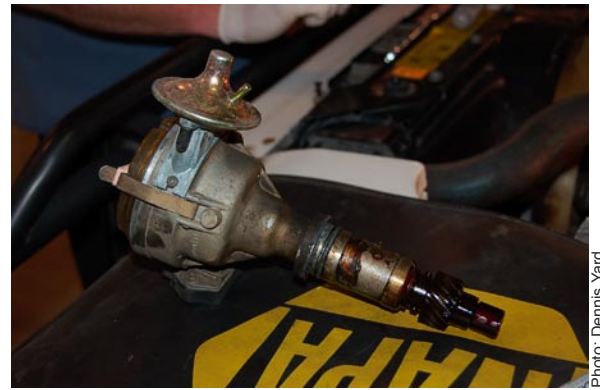
Photo: Step 6 - Lucas distributor removed

6. Pull the distributor body from the engine. Be careful not to disturb the gunk surrounding the distributor so it falls into the camshaft/oil pump drive well. Note the location of the oil pump drive tang at the bottom of the well. It may have to be adjusted prior to the reinstallation of the distributor shaft. This is noted in the instructions.

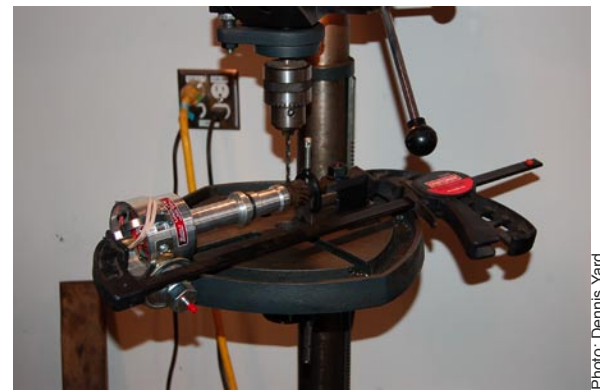
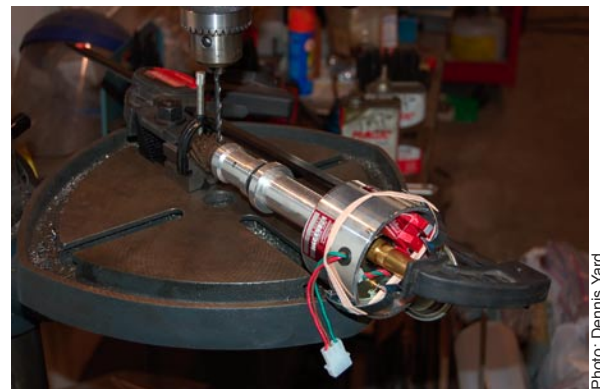
Photo: Step 10 - Drilling the shaft for the gear pin

9. This dry assembly is to ensure that the proper end float allows for oil to get to the shaft. At this point the shaft is drilled with the matching new hole. Be careful on drill selection to match exactly the roll pin hole diameter so there is not excessive play or too small a hole.

10. See pictures for the clamping arrangement used to prevent slippage of the parts while being drilled and maintaining proper alignment.

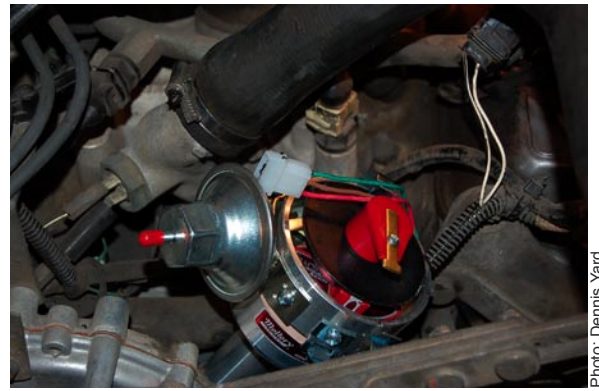
Photo: Step 14 - Installing the new distributor

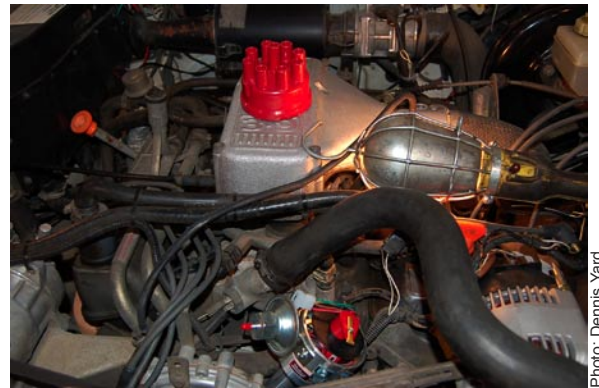
Photo: Step 16 - Initial distributor timing alignment

19. If all is well, turn on the battery power switch and try to start the engine. If the engine is correctly statically timed, then it should start. Once started, the exact timing can be set using a timing light or similar device. Once correctly set, the locking plate nut can be tightened and the timing checked again to ensure it remained correct.

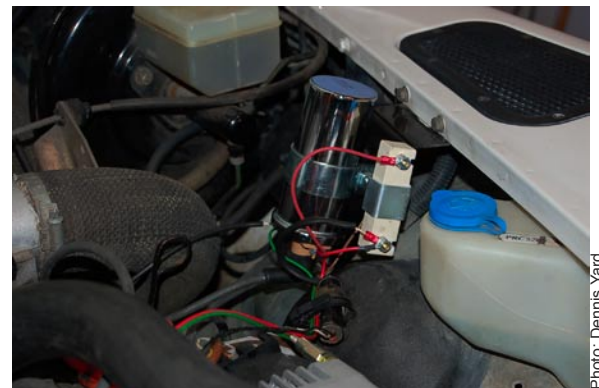
Photo: Step 17 - Installing the coil and ballast resistor

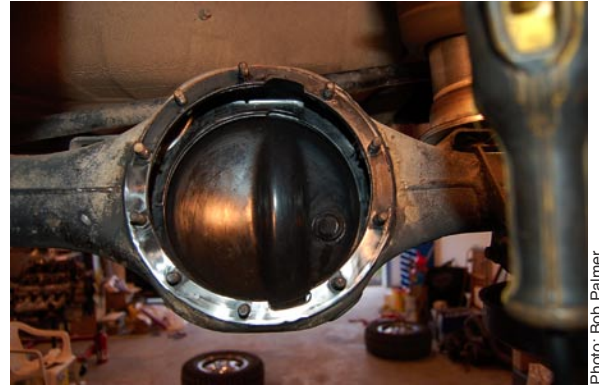
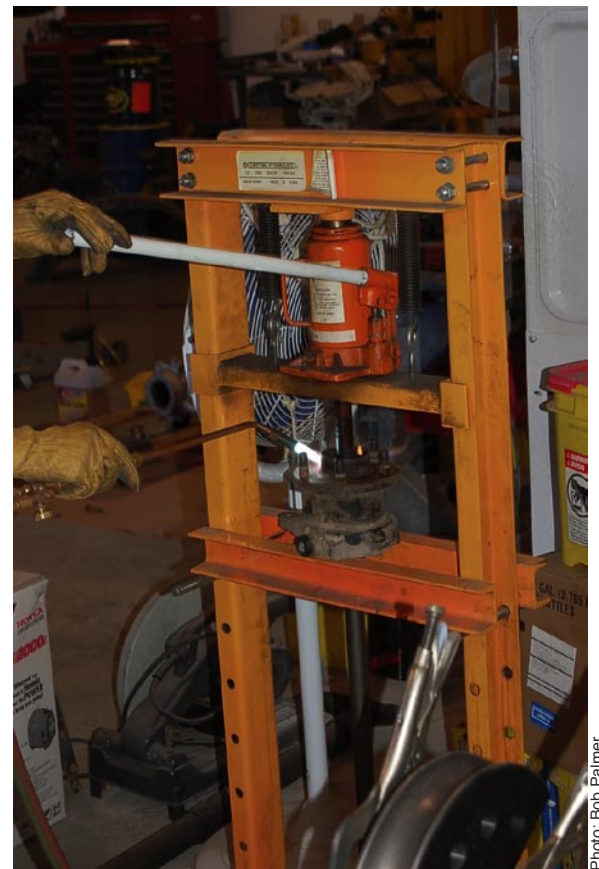
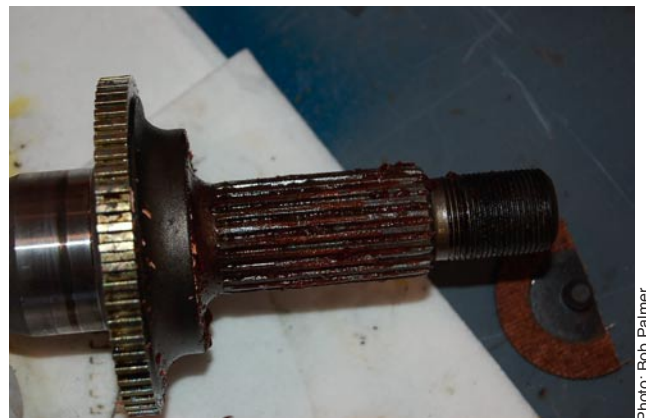
Joe had experienced this on his Range Rover also. The solution is to machine about 0.100 inches off the axle flange that sets the axle position relative to the hub. It appears the effective depth of the splines on the current Land Rover axle are not deep enough for the locker. So now we had to remove the axle from the hub. This should be floating, held in place by the axle nut on the outside of the hub. However, we could not get the axle nut off, even using in pneumatic impact wrench. Nick ended up buying a bigger impact wrench, and after a minute of pounding the nut finally came free. But the axle still would not slide out of the hub. Land Rover axles are supposed to be field replaceable, but we were having problems working in a shop. We took the axle and hub over to the 12 ton hydraulic press, nothing moved. Next we sprayed penetrating oil on the axle, and hub, and trying pressing again. Still nothing. Finally we got out the torch to heat up the hub. This is risky, because we didn't want to damage the wheel bearing in the hub. Finally with heat, oil, and 12 tons of pressure the axle broke free from the hub and we were able to press it all the way out. Between rust, and the red Loctite that the Land Rover manual says to apply to the axle

Bottom: Rust and red Loctite on the hub axle splines

Left: Machining the axle flange

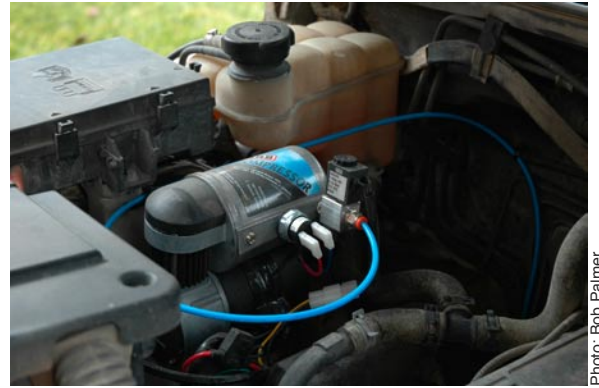
Above: ARB Compressor mounting and air line

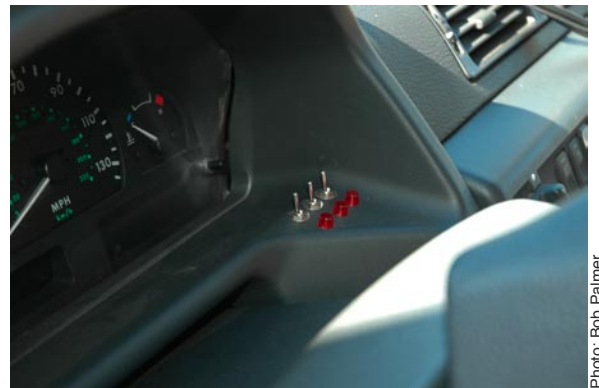
Below: Compressor and Locker control switches

The final step was the electrical control lines. The compressor has a relay that is powered directly off the battery, but the control wiring must be brought through the firewall and into the dash where it can be easily reached. An unused plug through the firewall was found behind and below the radiator expansion tank. The control wires were routed through this plug, and then underneath the center console. The ARB supplied switches are rather large, and it would be difficult to integrate 3 of these switches into the dash. So miniature toggle switched with separate indicator lights were used. The switches and indicator lights were mounted on a flat part of the instrument cluster bezel in front of the trip odometer reset button. This is out of the way for ordinary driving, but easily accessible for off-road use. The ARB wiring harness had an activation order that had to be preserved, but this is easy to deduce from the wiring diagram. The first switch activates the air compressor, and allows activating the first (rear) locker. If the compressor is not activated, the locker solenoid will not turn on. The second switch activates the first (rear) locker, and allows activating the second (front) locker. You can not activate the front locker, unless the rear locker is also engaged.
